Disaster Mitigation Working in Alaska

Flood Mitigation in Nome, Alaska

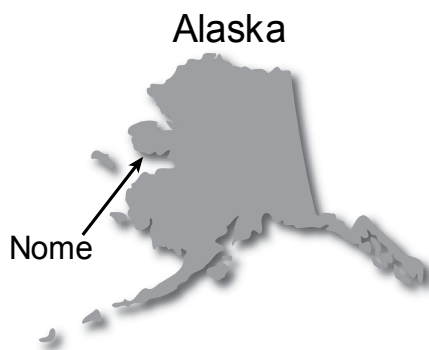
The 1949 drainage culverts had rusted and collapsed

Nome had experienced severe storms several times in its history, starting with an event in 1900 that left 1,000 homeless and destroyed the business district. More terrible storms followed and, in 1949, the U.S. Congress allocated \$1 million to build a seawall and drainage system. Strong storms continued to top the rip-rap structure and eventually the old 12 inch drainage pipes serving the downtown began to rust and collapse.

A solution began to come together in 2005 with a proposal by the Alaska Department of Transportation and Public Facilities Northern Region (DOT&PF). The project would replace and upgrade the old, failed culverts to a system of five new 30 inch diameter, one-half inch thick galvanized steel pipes.

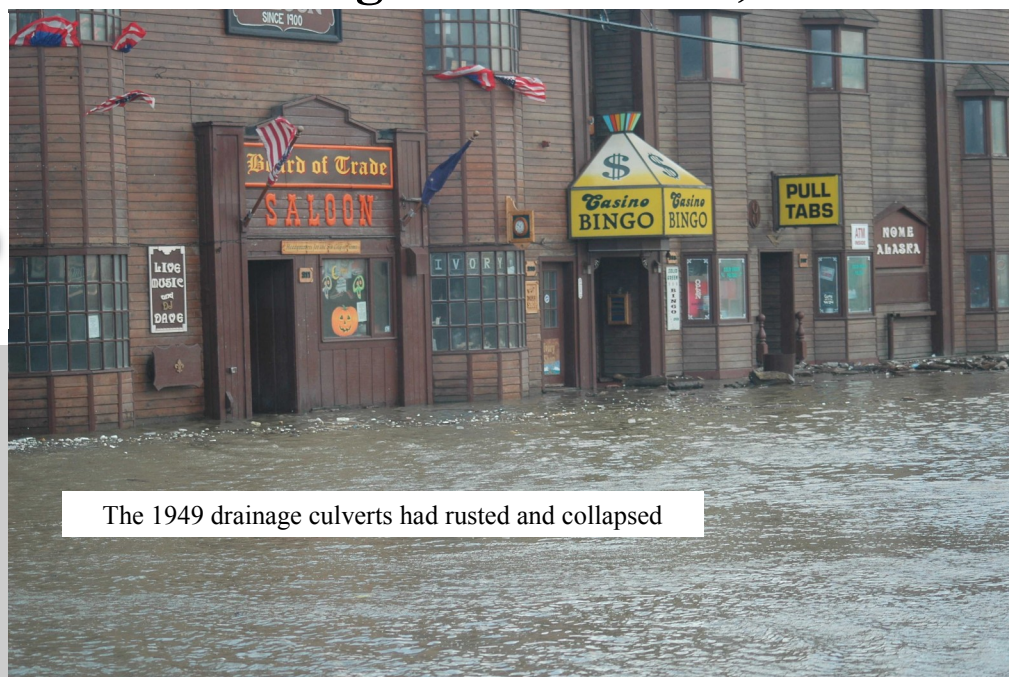
Damage prevention investments in 1949 and 1993 helped to protect the city, but high winds and water levels still managed to top the seawall and damage buildings along Front Street.

2004 flooding on Front Street

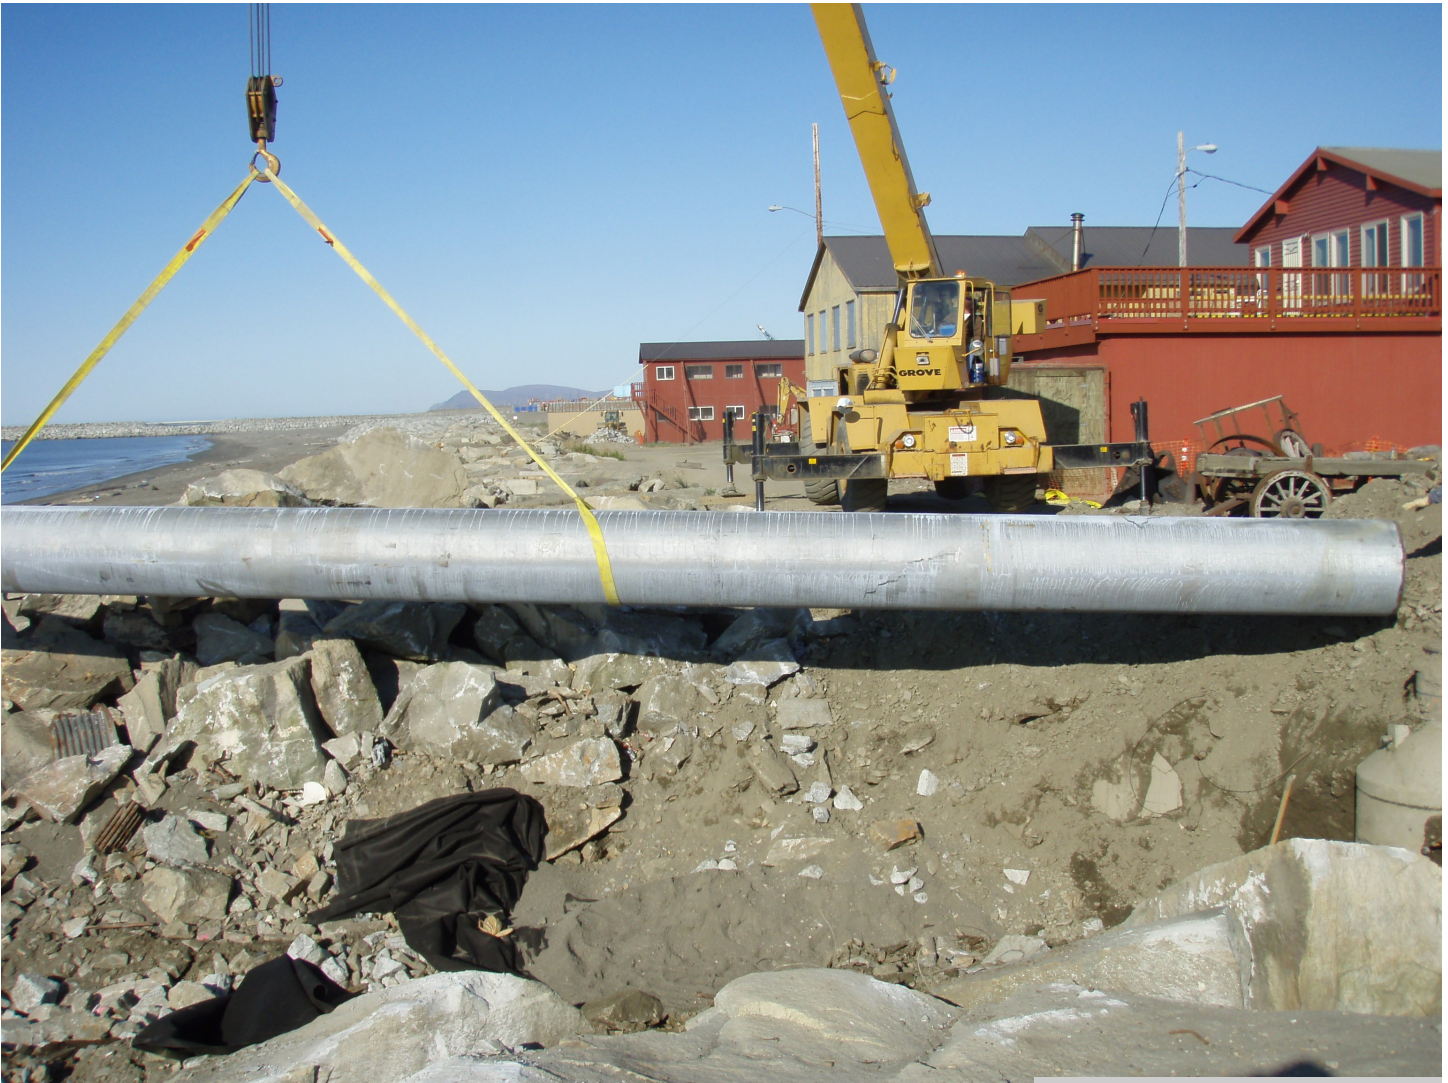
Large diameter culverts being installed through the seawall

the rip-rap seawall; equipment that's not usually available in a remote Alaskan community. Thick-wall galvanized steel pipe was ordered from a fabricator in Puyallup, Washington. The load was transferred to a barge in Seattle, then towed all the way to Nome. Amazingly, one pipe per day installation was accomplished with the final pipe installed on September 13, 2008.
