Disaster Mitigation Working in Alaska

Elevated Homes in Alakanuk Stay Dry – So Far

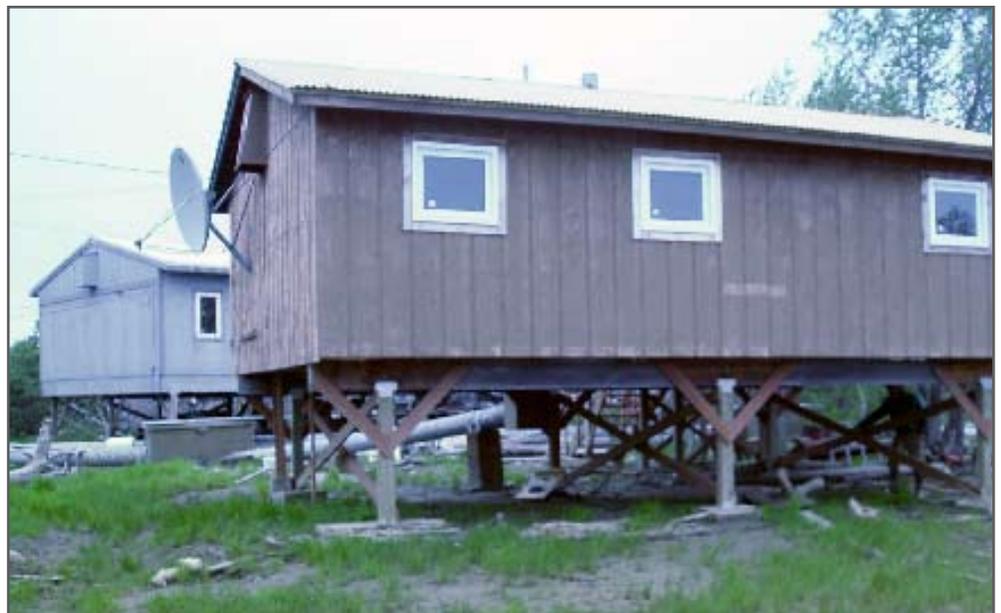
Alakanuk home elevated 6 feet on post and pile foundation in 2005.

In 2005, eight homes and the City of Alakanuk office building were relocated, and all but one of the homes were elevated, most of them to a height of 6 feet above the natural ground surface,

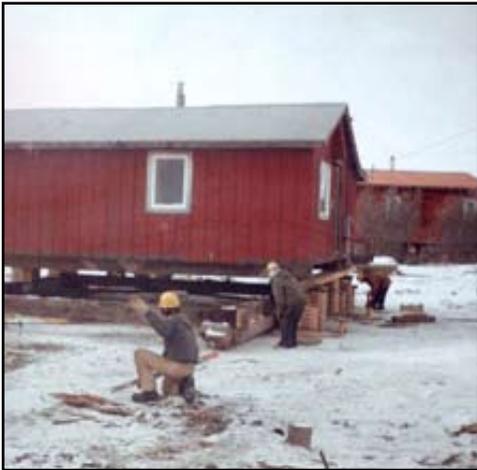
Process of elevation

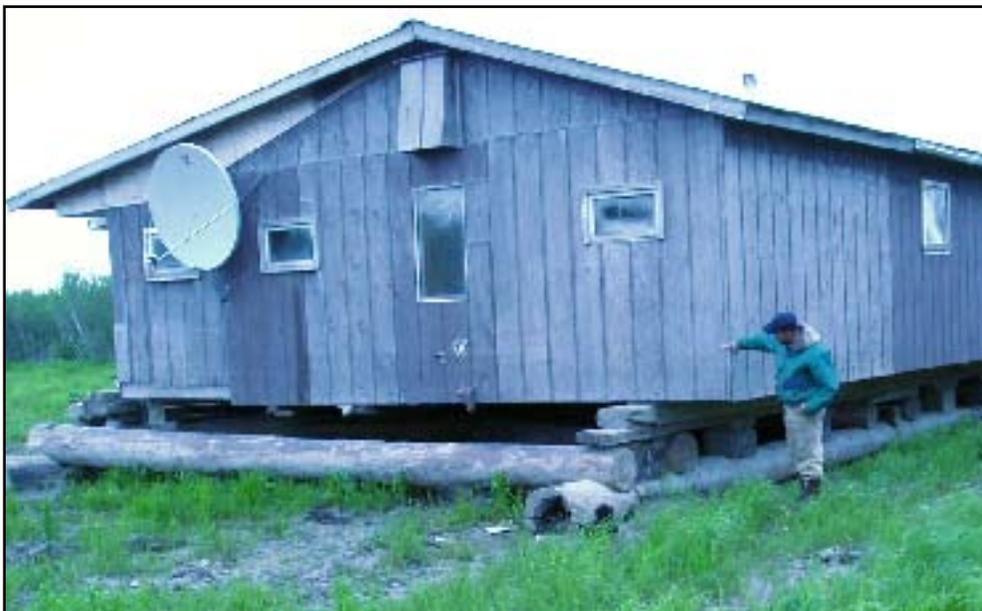
This Alakanuk home had been moved but not yet elevated when the 2005 floods struck. The owner's son is pointing at the level reached by the flood.

In May 2006, snowmelt and ice-jam flooding on the lower Yukon caused inundation of Alakanuk with ice-laden water to depths up to 6 feet. At least one home, which had been within 30 feet of the river before it was relocated and elevated, would surely have been destroyed by the water and ice blocks the size of cars at its original site. This home and the six others that had been relocated and elevated escaped damage to the main structure. In the home that had been moved but not yet elevated when the floodwaters struck Alakanuk in 2006, the floor and some insulation was damaged by 4 to 5 feet of water.
